EVIDENCE BOOK

CASE STUDY - RACKING COLLAPSE

INCIDENT REPORT BRIEFING RACKING COLLAPSE

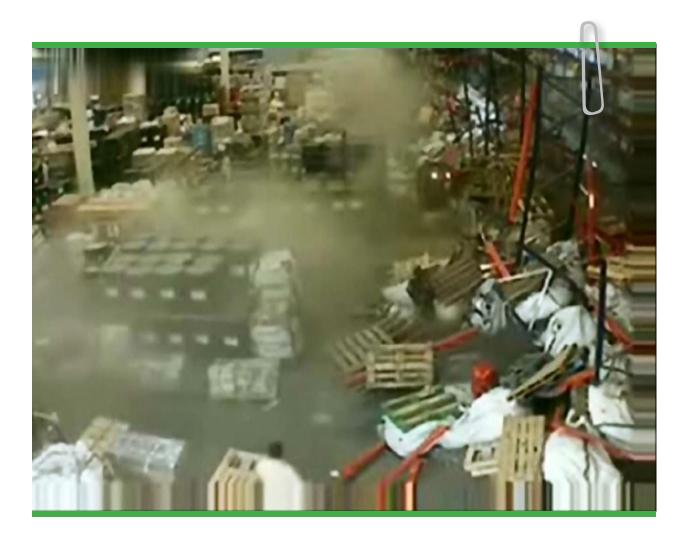
An accident has happened at Trafalgar Distribution in their main warehouse. A worker, Horatio, has been injured; he has a broken arm, cuts and bruises.

Below is a photograph taken of the aftermath.

So I kept going through the gap, thinking the alarm would sound if I got too close - but of course it didn't. The timber contacted the racking and it all came crashing down. I just leapt out of the cab as an instinctive reaction - against my training. Unfortunately, something fell on me and broke my arm.

I was back in the office (it must have been about 2.35 pm) when I heard a massive crashing sound. I raced out to the warehouse to see a whole row of racking had collapsed. Horatio was standing by the wall holding his arm. Nelson was with him, giving him first aid. I phoned the ambulance; it arrived at 3pm and took Horatio to hospital.
